Title: Examination of Intergranular Crack on SC0234

Examination of Intergranular Crack on SC0234

Brian Berger, AMPP-1
Rene Chavarria, AMPP-1
Stanley W. Pierce, AMPP-1

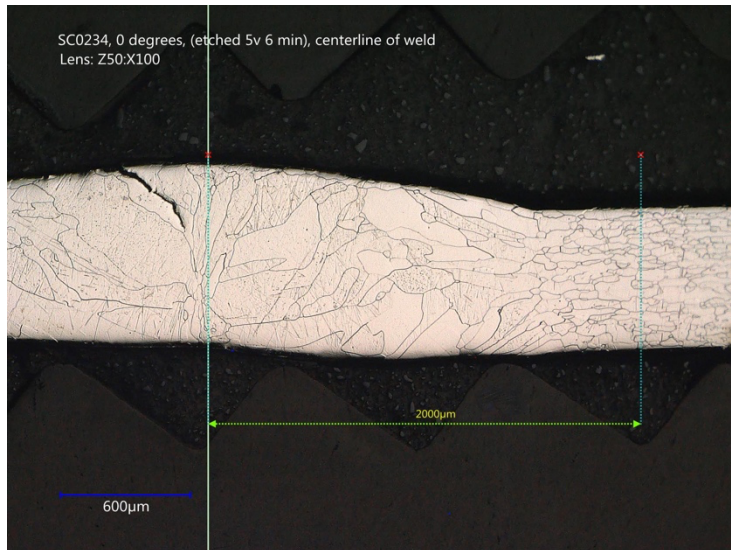
Metallographic examination of the weld cross sections revealed the microstructure to be typical of GPHS welds with the exception of an intergranular fracture in the 0-degree weld cross section (Figure 1, Figure 2). The crack occurred in the final portion of the weld, at the vent location prior to the weld start. The crack begins on the weld surface, 1014 microns to the left of the weld centerline, extends into the weld for 420 microns, and terminates 108 microns to the left of the weld centerline.

Figure 1 Weld cross section at 0 degrees showing evidence of crack

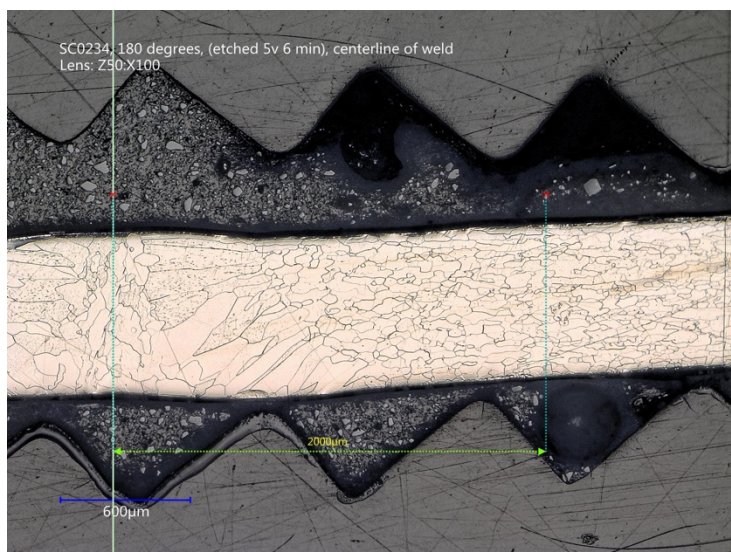
Figure 2 Weld cross section at 180 degrees

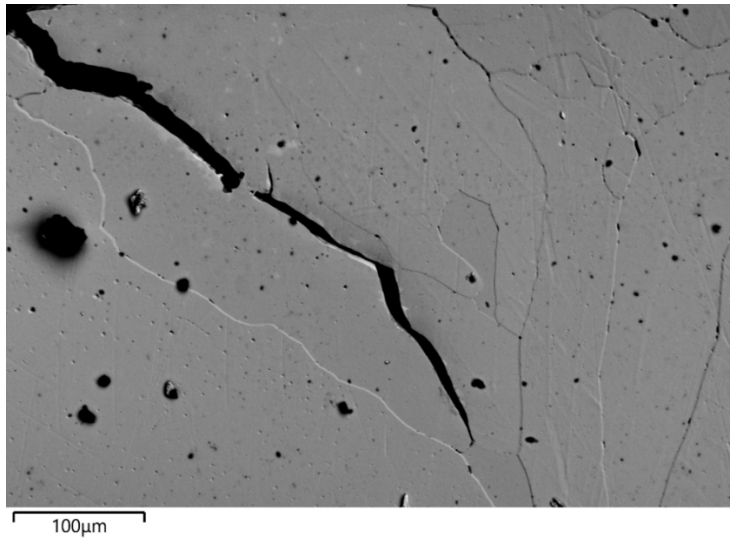
Secondary electron imaging confirmed that the crack propagated along the grain boundary and terminated at a grain triple point (Figure 3). The crack tip is blunt and it is preceded by a series of voids in the remnant of what was a liquid film along the grain boundary (Figure 4). This type of crack is known as a solidification crack and it occurs due to thermal tensile stress and reduced grain boundary strength and the presence of a liquid film during final solidification and grain formation. DOP-26 is known to exhibit the formation of a low melting temperature, grain boundary thorium/iridium eutectic that contributes to this type of cracking.

Figure 3 Secondary electron image of crack.

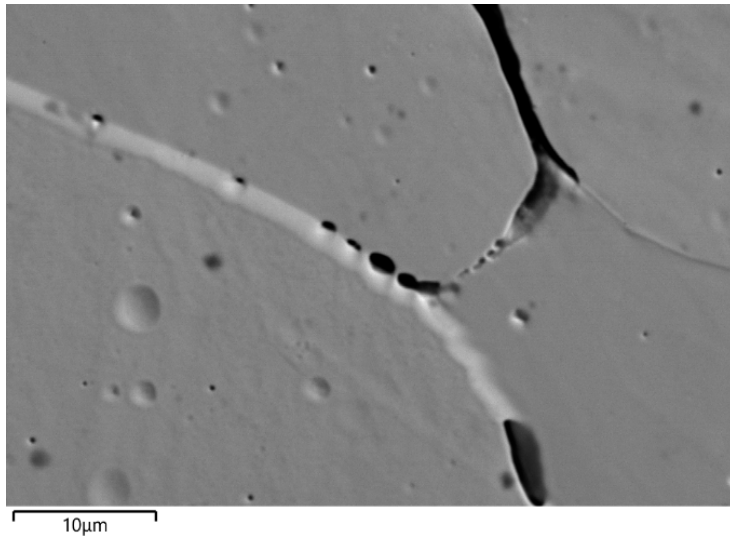
Figure 4 Crack front showing pores.

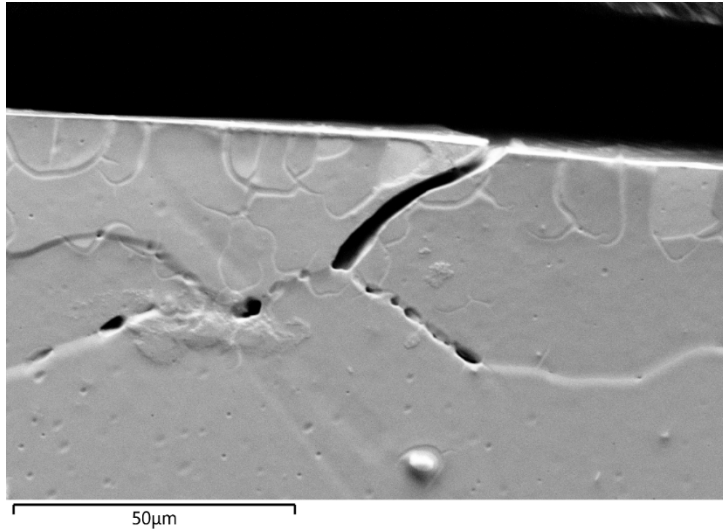
An additional crack of much smaller size was identified by the SEM (Figure 5). The crack is also intergranular but in comparison to the larger crack it is only 50 microns in length. The crack also terminates at a grain triple point and is preceded by voids. This crack was not discovered during the metallography examination due to it being located near the samples edge and the limited depth of field of optical microscopes. As with the larger crack this fracture appears to be consistent with solidification cracking.

Figure 5 Small crack with pores on grain boundary.

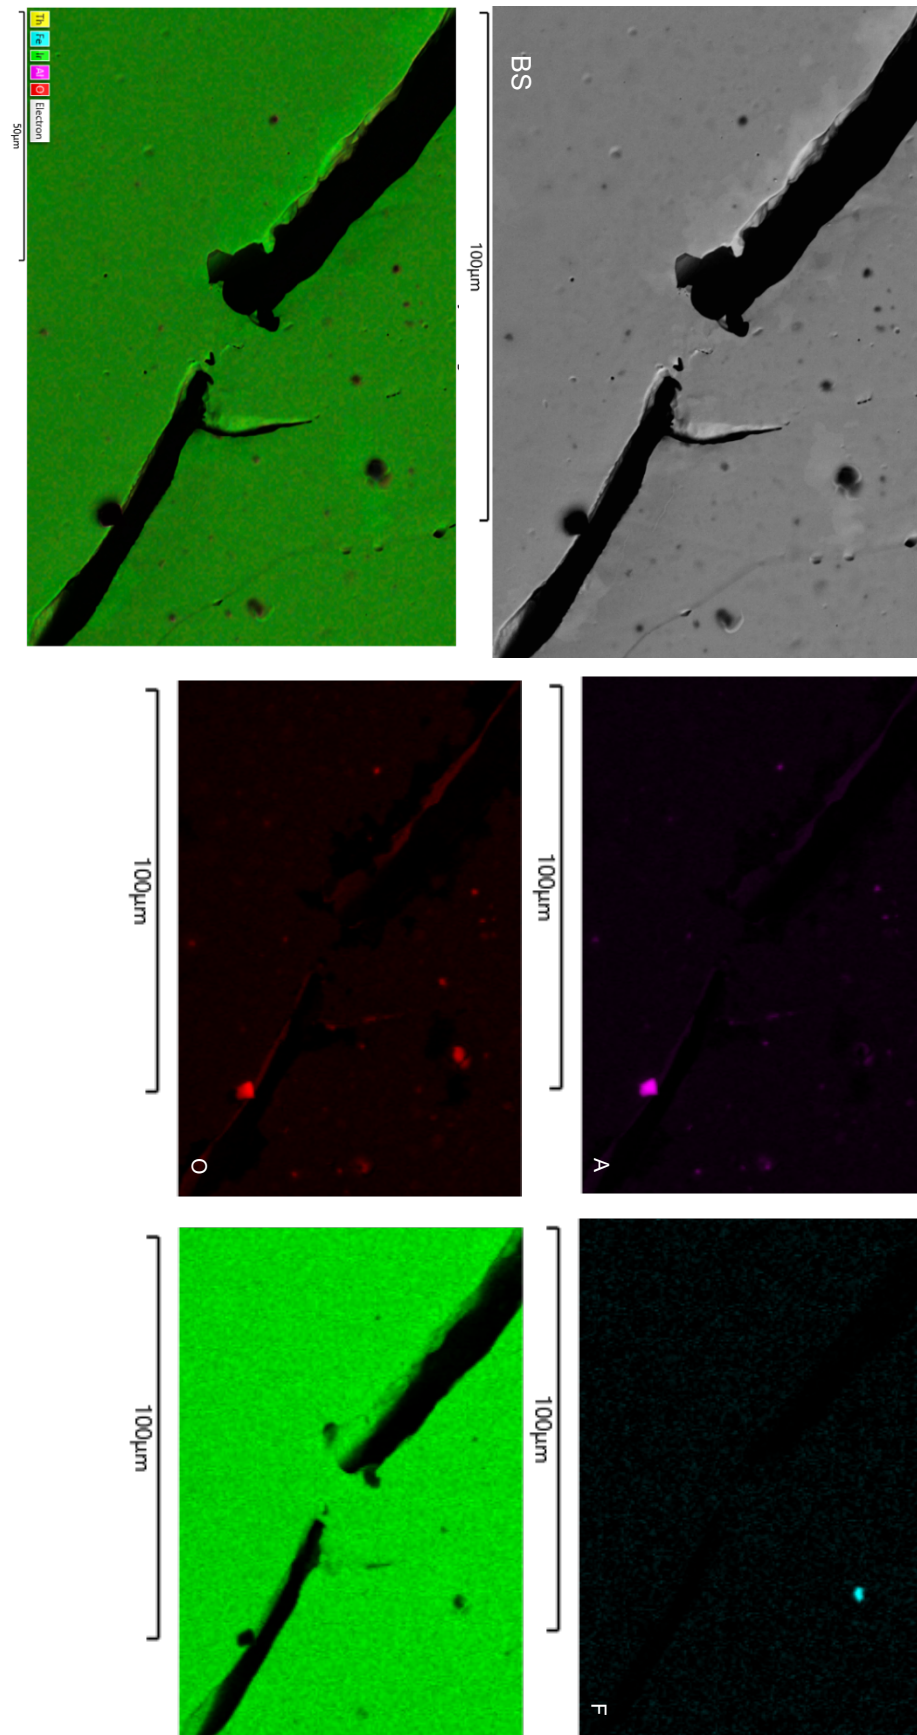
Although the thorium/iridium eutectic is known to be associated with this type of cracking in the DOP-26 alloy, EDS analysis did not identify any secondary phases or abnormal concentrations of thorium or contaminants along the grain boundaries despite the presence of liquid film at the grain boundary. There is no clear reason for this anomalous crack in an otherwise normal weld after many years and several hundred successful welds. The crack is the result of the alloy composition and weld stress. A slightly high or localized concentration of thorium could be a contributor. In addition to the normal weld thermal stress, there may be additional variable stress in the area of the vent due to internal pressurization of the clad as the vent is sealed.

Figure 6 EDS analysis of material surrounding the large crack.
